New York State Department of Transportation

Yellow Flag NB2358W017

BIN: 1065318

Location: Stringer S1 in Span 164 at Pier 164 between 38th-39th Street.

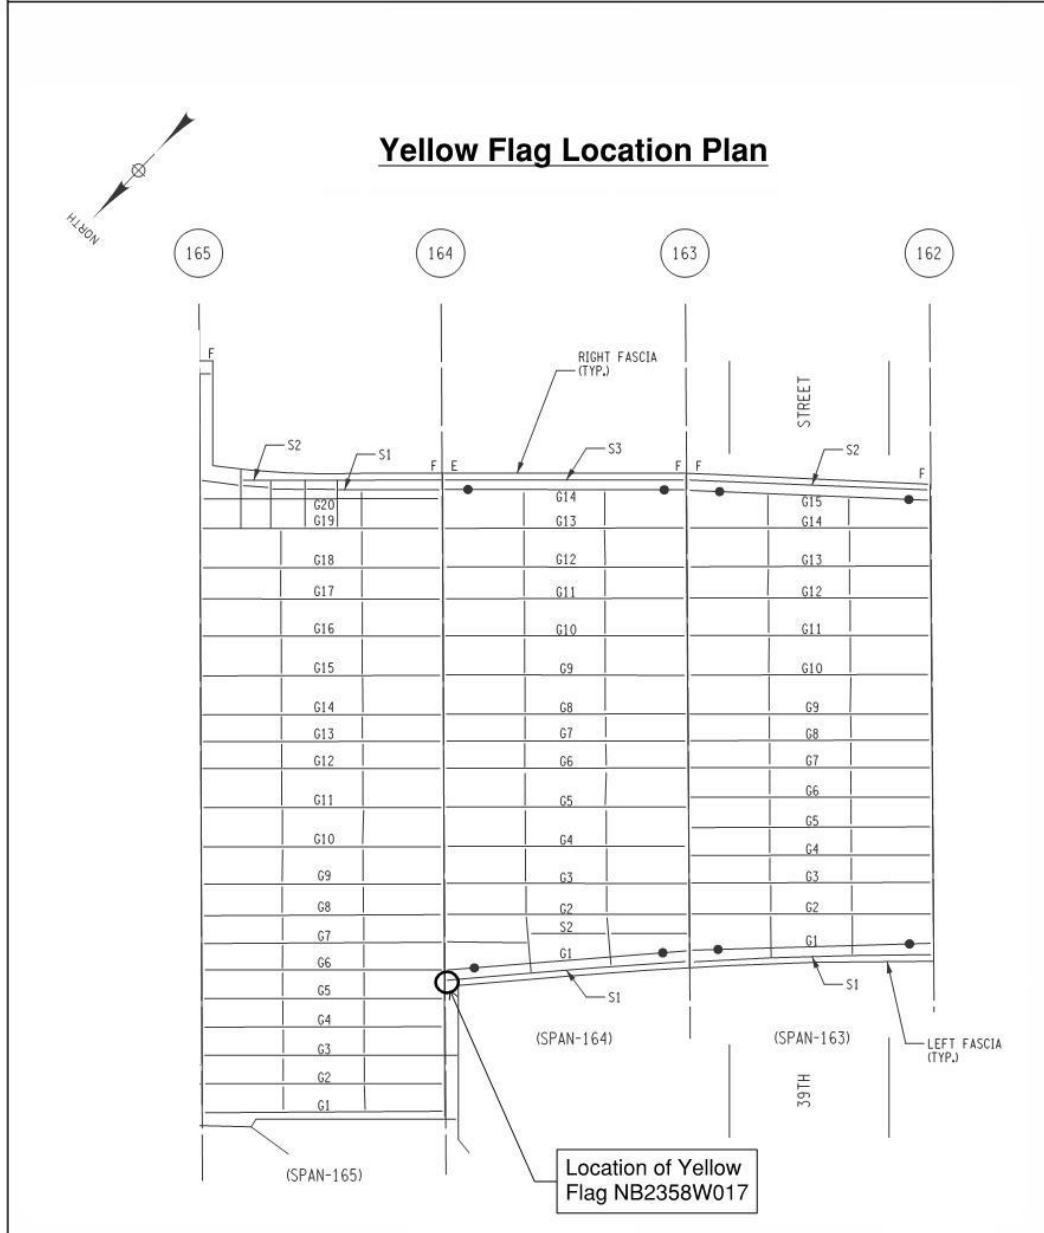
Flag PhotographsPhoto Number: **1**Photo Filename: **23_Flag Location Plan.jpg**Gowanus Expressway
2023 Biennial Inspection - Field SketchBIN: 1065318Team: AA/TSDate: 06/01/2023Span: 164Location: Transverse Beam Below S1 at Pier 164

**wsp****Attachment Description: Flag Location Plan**

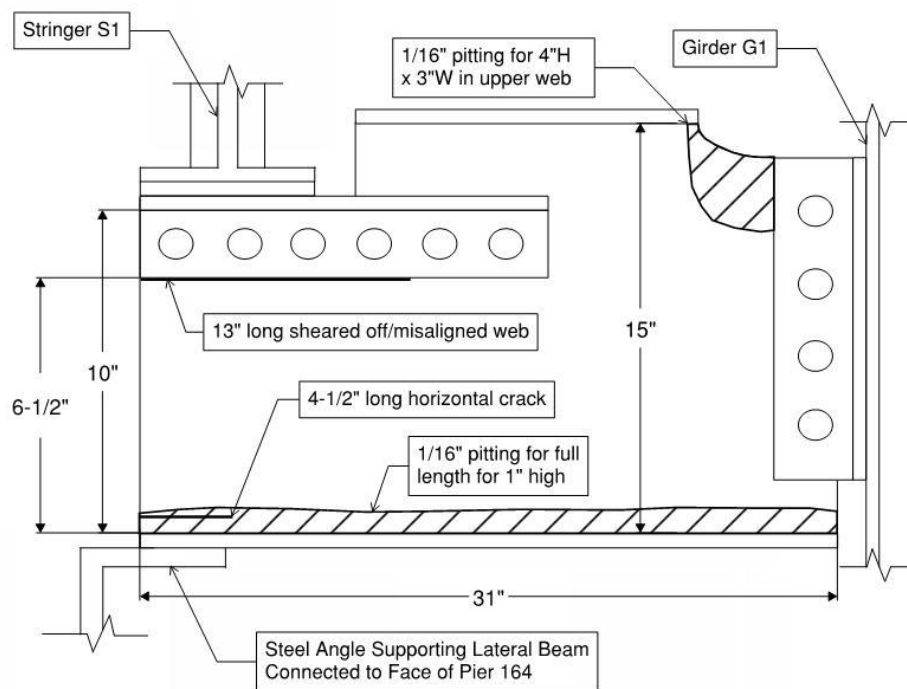
Photo Number: 2

Begin Face of Lateral Support
Beam Below Stringer S1

-As-measured web thickness of lateral support beam is approximately 0.25"

Attachment Description: Flag Condition Sketch

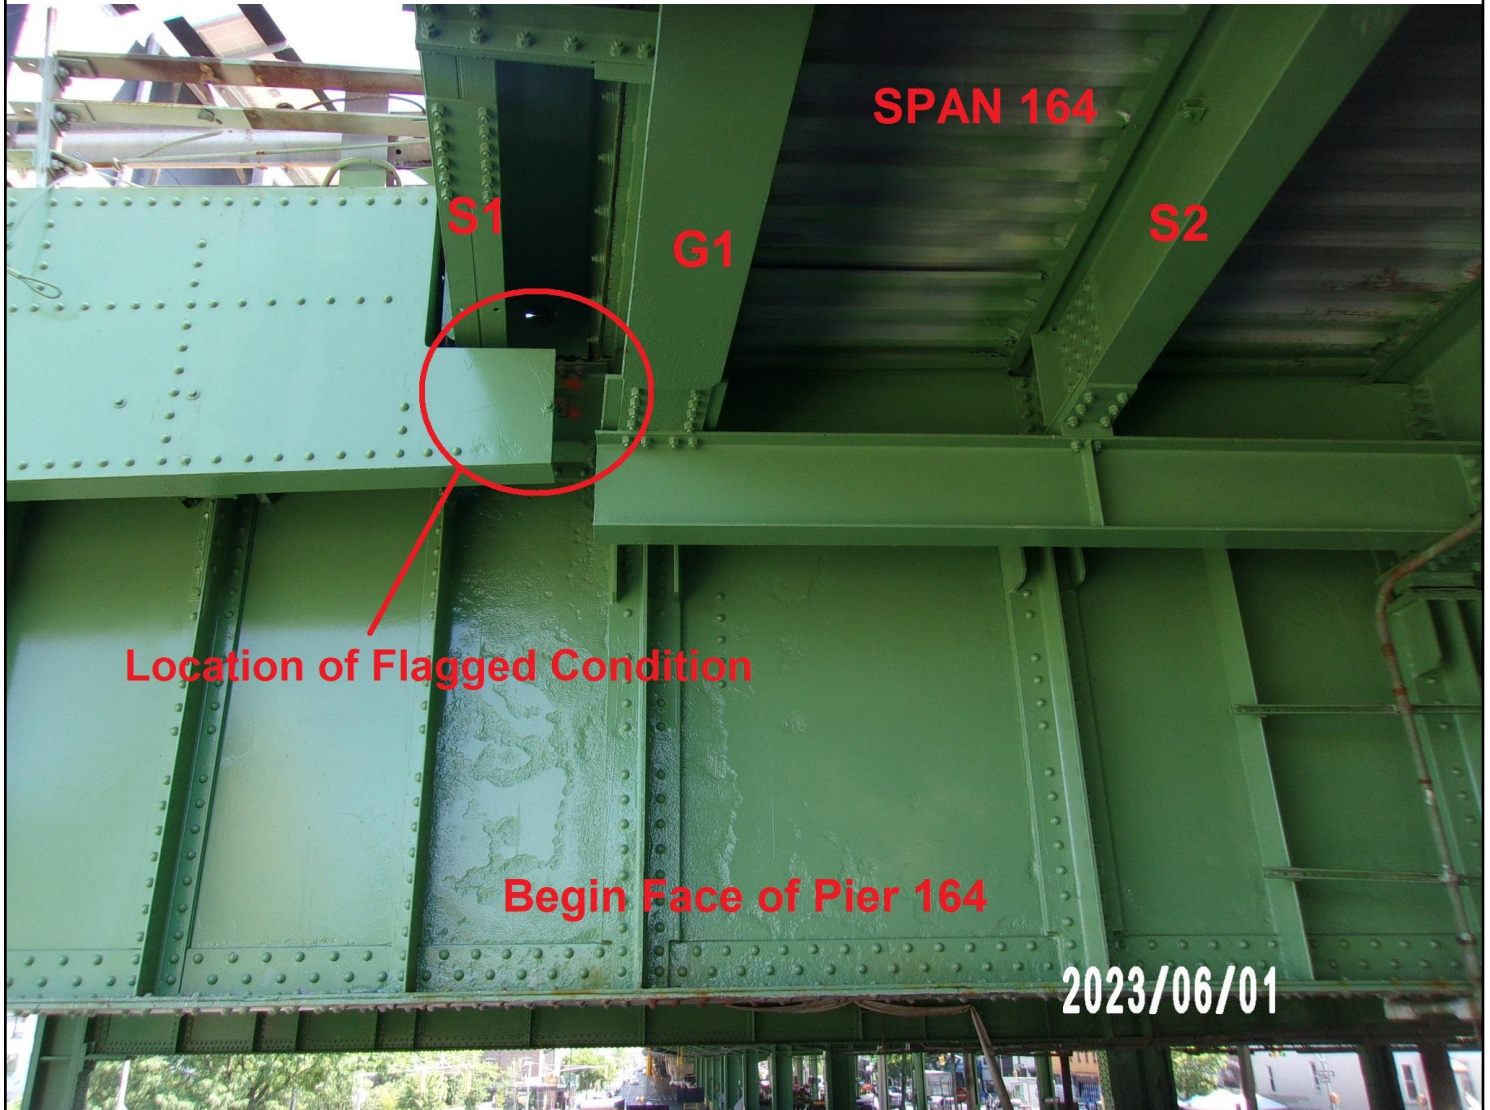
Photo Number: 3

Attachment Description: General view of the flagged condition at the transverse support beam below Stringer S1 in Span 164 at Pier 164. Looking End.

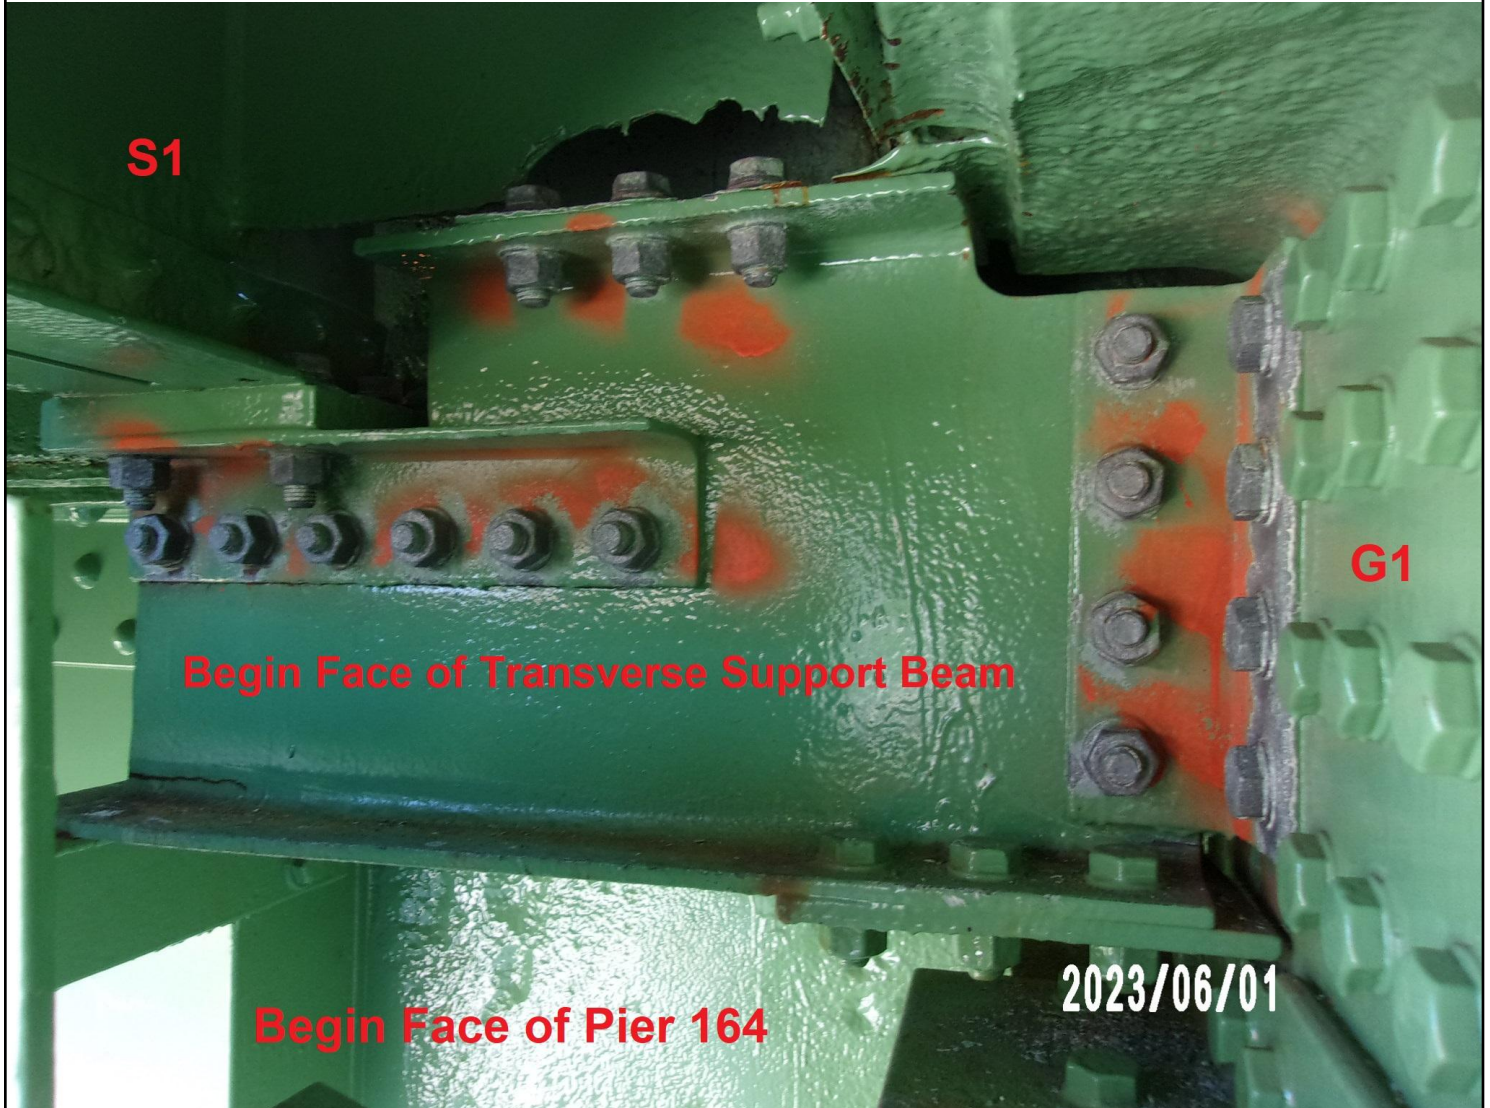
Photo Number: 4

Attachment Description: Close up general view of the flagged condition at the transverse support beam below Stringer S1 in Span 164 at Pier 164. Looking End.

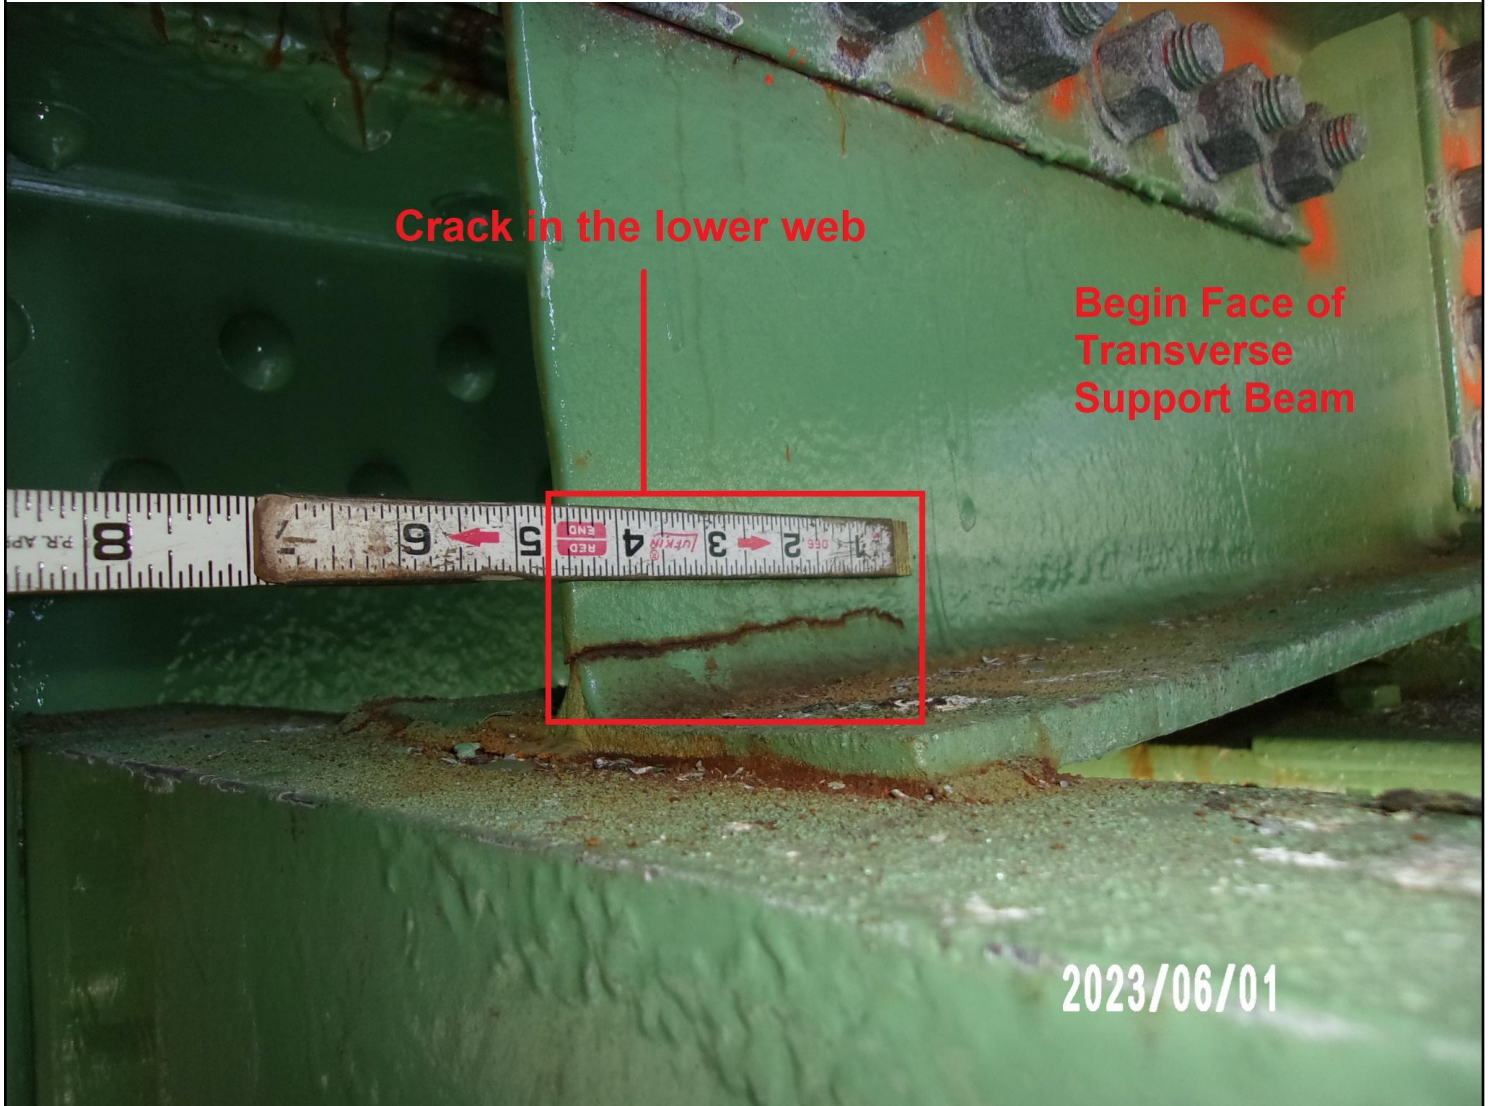
Photo Number: 5

The transverse support beam connected to the left face of Girder G1 supporting the end of Stringer S1 in Span 164 adjacent to Pier 164 exhibits a 4-1/2" long crack (previously 4" long) in the lower web (Photo 5) and 13" long (no changes since previous inspection) sheared/misaligned portion of the upper web (Photos 6 and 7). The sheared/misaligned portion and crack are both located directly below Stringer S1. The crack in the web is located directly above the bottom flange. The sheared/misaligned portion of the web is located right below the top flange angles. The top of the sheared/misaligned portion of the web is displaced towards the begin side (previously the portion of the web was leaning towards the end side). The transverse beam exhibits 1/16" pitting for the full length of the lower web (approximately 31" long) for 1" high and in the upper web adjacent to the connection to the Girder G1 web for 4"H x 3"W (Photo 8). The connection angle between the transverse support beam and web of Girder G1 is in good condition. The bearing plate between the bottom of Stringer S1 and top of the transverse support beam is in good condition. (refer to Yellow Flag Condition Sketch Photo #2 for more details)

Attachment Description: The left end of the transverse support beam below Stringer S1 in Span 164 at Pier 164. The lower web of the support beam exhibits 4-1/2" long crack right above the bottom flange. Looking End and Right.

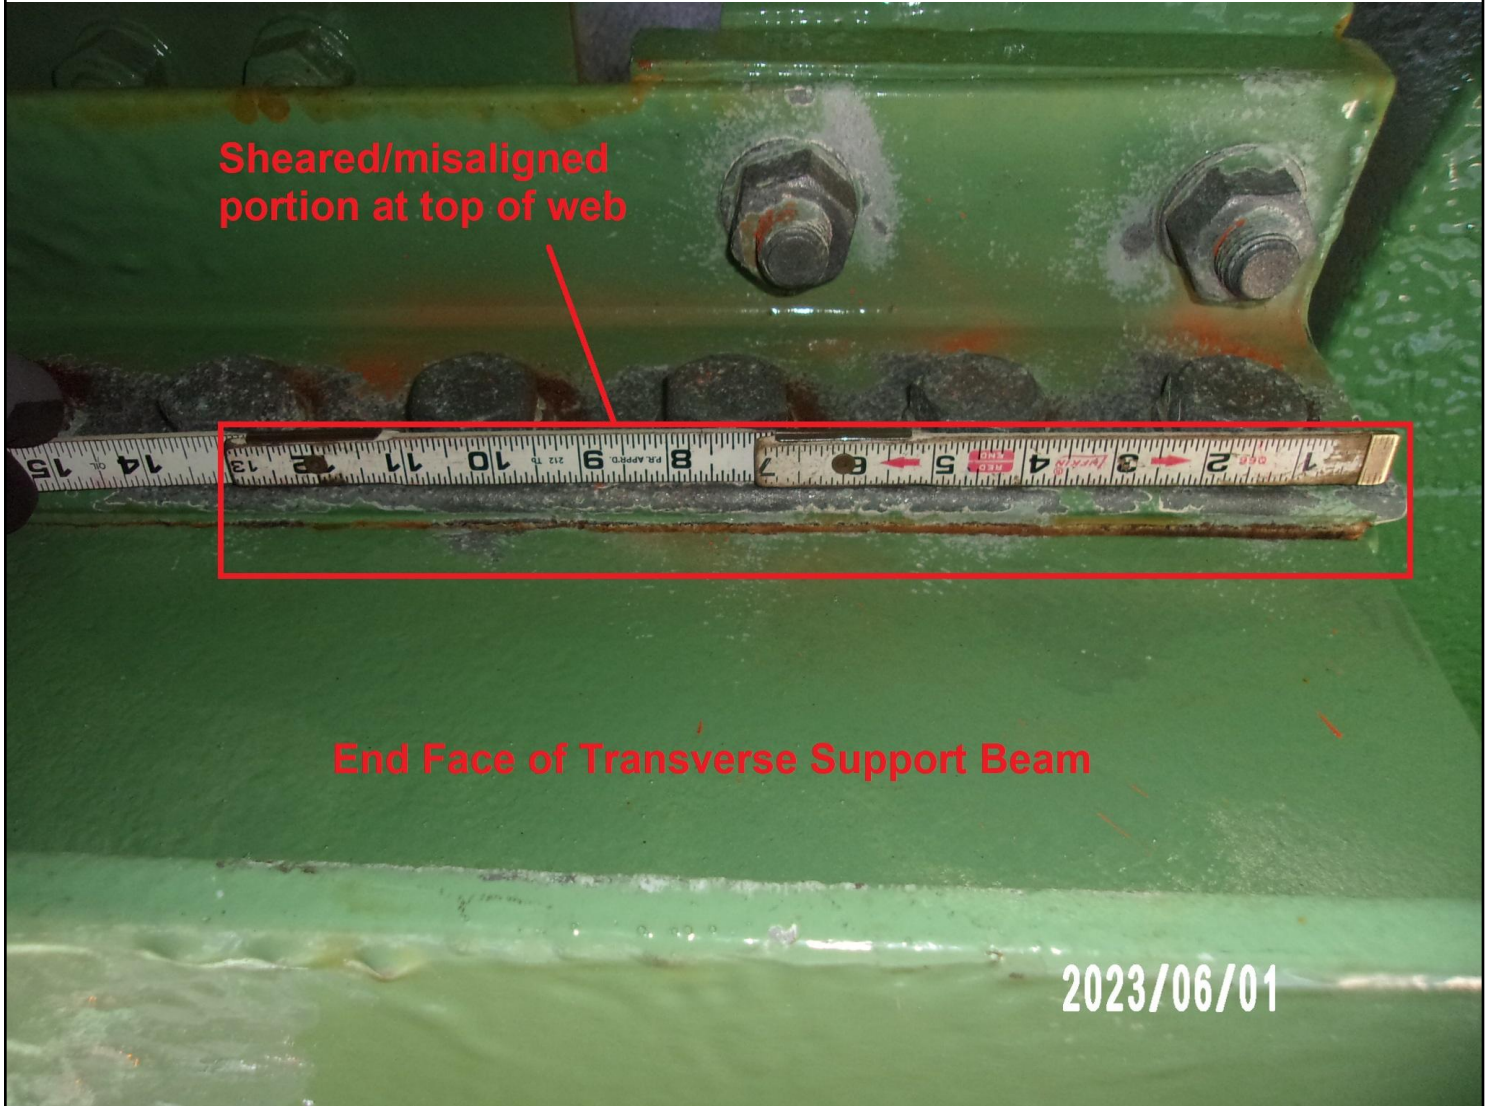
Photo Number: 6

Attachment Description: The end face of the transverse support beam below Stringer S1 in Span 164 at Pier 164. The upper web of the support beam right below the top flange angles exhibits sheared/misaligned portion of the web for 13" long. Looking Begin.

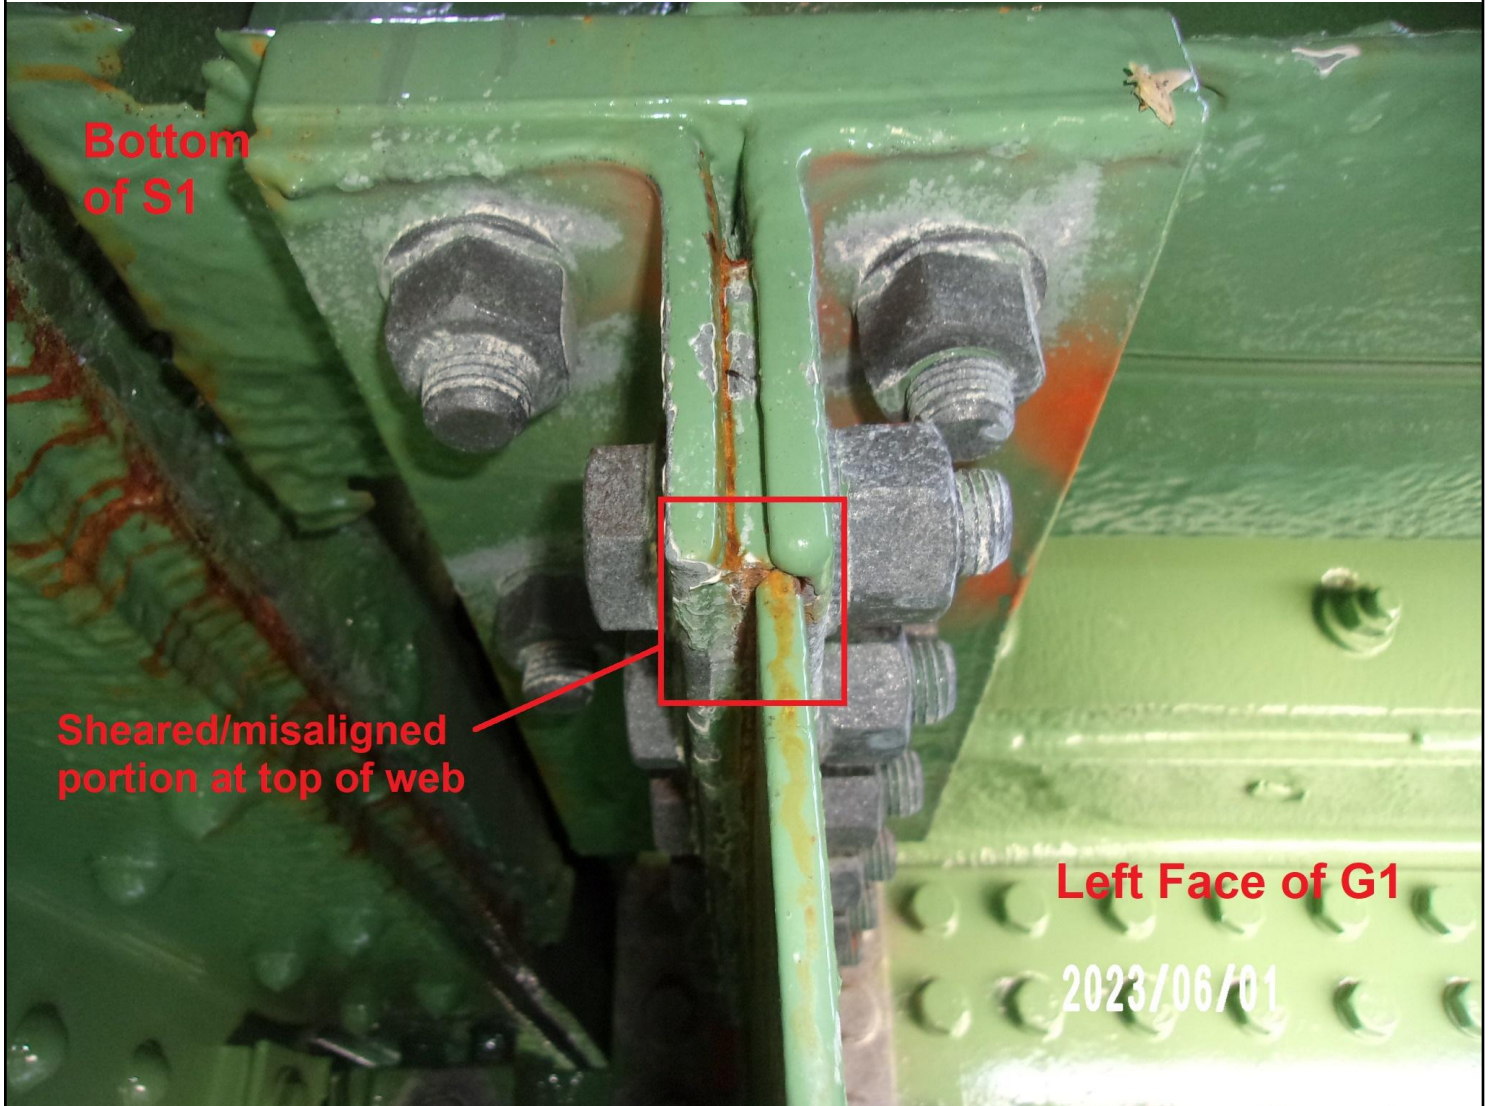
Photo Number: 7

Attachment Description: The left end of the transverse support beam below Stringer S1 in Span 164 at Pier 164. The upper web of the support beam right below the top flange angles exhibits sheared/misaligned portion of the web. Looking Right.

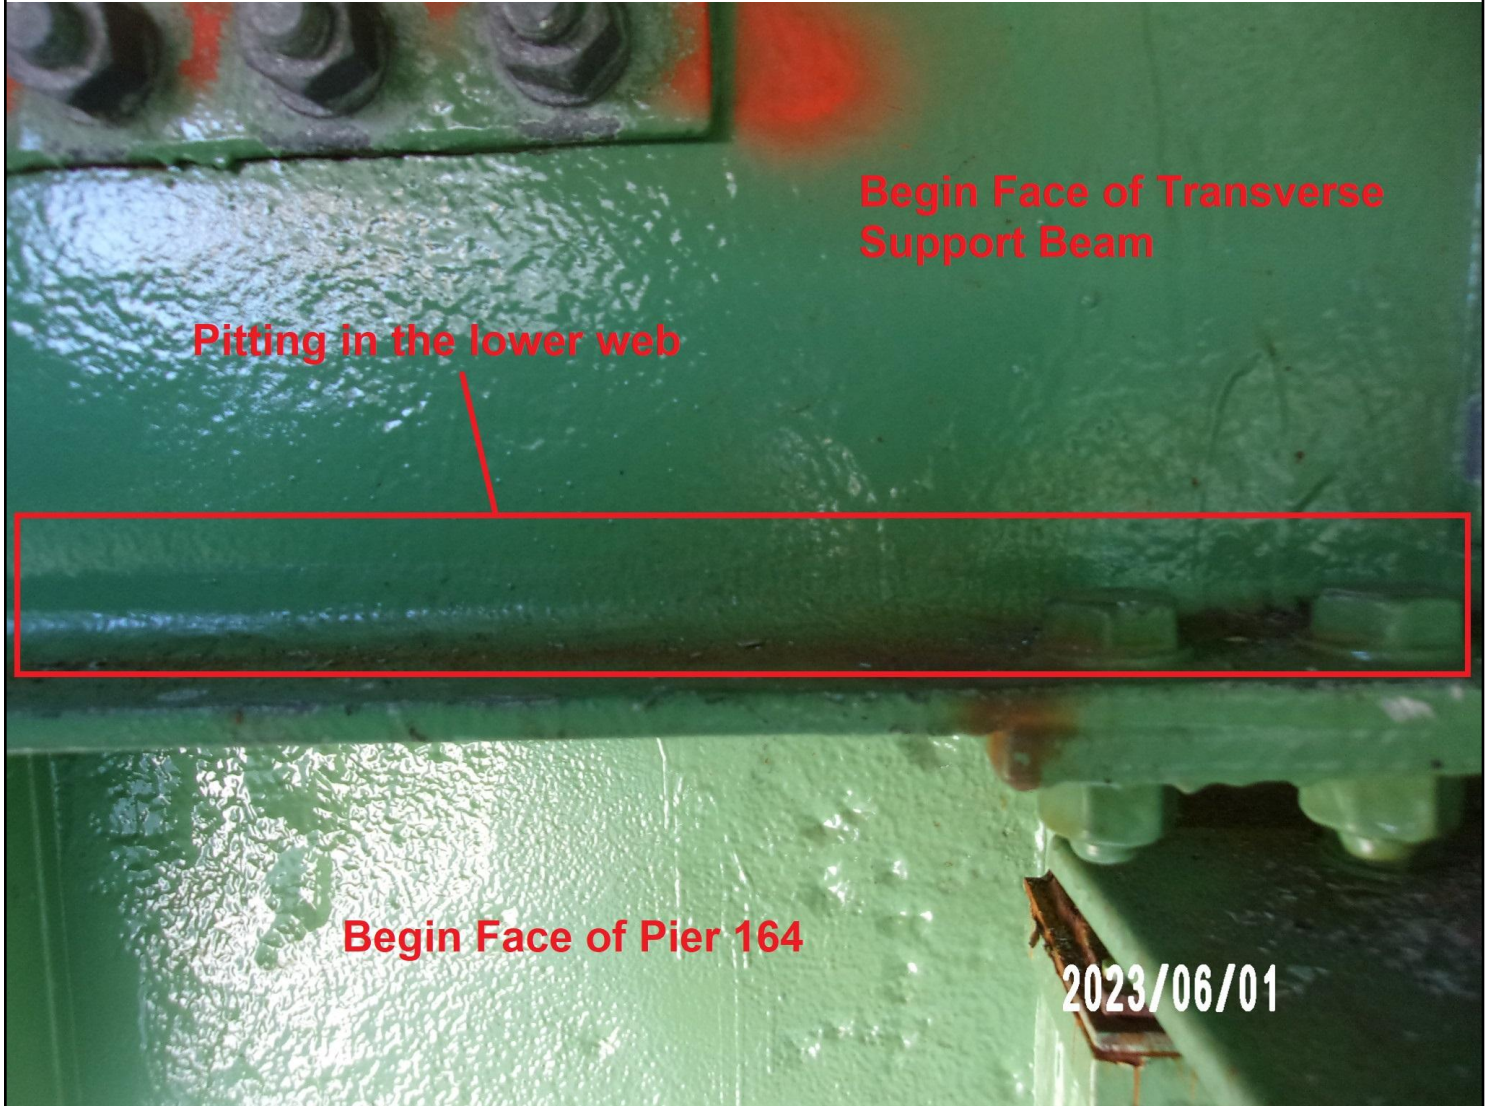
Photo Number: 8

Attachment Description: The begin face of the transverse support beam below Stringer S1 in Span 164 at Pier 164. The lower web of the support beam above the bottom flange exhibits 1/16" pitting. Looking End.
